Soil Testing for Various Heavy Metals in and around Some Schools of El Paso Independent School District (EPISD)

Center for Environmental Resource Management (CERM) The University of Texas at El Paso (UTEP)

October 17, 2016

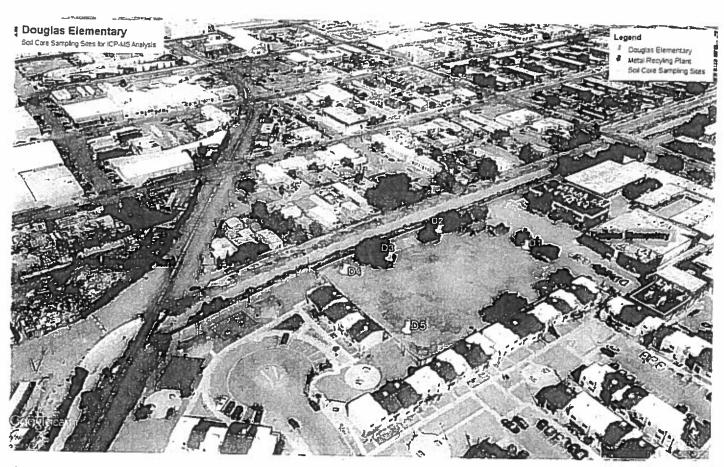
Figure 1: Google Earth Image of the five locations points at Douglas Elementary School

- 2. Using these criteria, no sample that we collected at Beall, Douglas, Zavala, or Bowie schools met the high risk category for lead (>400 ppm). Two samples met the criteria for moderate risk; one at Douglas Elementary playground (218 ppm) and one at Zavala Elementary school (156 ppm). One other sample at Douglas Elementary (135 ppm), one sample across the street from the school (134 ppm), and one sample from the Salazar Housing Complex playground (126 ppm) were close to 150 ppm ranging from 126-135 ppm.

- 2. The Douglas Elementary playground contains lead levels with low to moderate risk, but depending on the bioavailability of the lead (not measured) could be moderate to high risk. We recommend that EPISD consider some remedial action at this site. The simplest and most cost effective action could be simply hauling in soil with a much lower lead level and covering the playground with 1-2 inches of fresh soil.
